# Rehabilitation of the West Tailrace Tunnel, Churchill Falls, Labrador

**ABSTRACT:** The Churchill Falls Hydroelectric Project was watered up in 1971. The west tailrace tunnel was dewatered for inspection after 28 years in service. Most of the 1700 m long tunnel was in excellent condition. However, a 50 m long zone of altered schistose rock had weakened and failed due to chemical and physical weathering. The paper describes the investigation and assessment of the rock conditions, including the nature of the alteration. The remedial work consisted of staged dewatering of the tunnel, preparation of rock surfaces, application of shotcrete, installation of rock bolts, drilling of drain holes and removal of the rockfall debris from the floor of the tunnel. The objectives were to isolate the altered rock from the flowing water and to reinstate the rock support that had been originally installed. The work was performed in the summer of 2001.

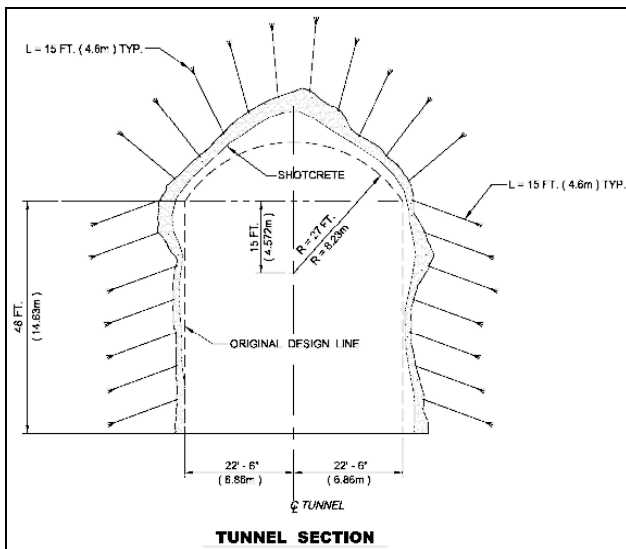
Figure 3. Tunnel Section.

Consequently, specifications were prepared and a contract was awarded for the rehabilitation of the altered zone by means of rock bolts and shotcrete. Figure 3 shows a section of the tunnel and support.

The design support was a minimum 100 mm thickness of steel fibre reinforced shotcrete and pattern rock bolts in the arch and walls. To ensure safety of personnel, the specifications required an initial minimum 50 mm layer of shotcrete on the arch prior to bolt installation. The robotic arm for remote application of shotcrete was also specified as a safety enhancement. Application of shotcrete in either one or two layers on the walls was dependent on a safety assessment of the rock conditions. In the event, the walls were shotcreted in a single layer after installation of rock bolts. A booster fan was used to enhance ventilation during shotcrete application. The barge was fitted with suspended “aprons” to catch rebound that would otherwise fall into the water.

Rock bolts, Grade 510 MPa (75 ksi), 22 mm in diameter and with mechanical anchors, were supplied in lengths of 4.6 and 6.1 m, with the longer bolts installed in areas of extensive rockfall where the tunnel size was significantly larger than the original design dimensions. The bolts were specified to be installed on a pattern of 2.1 m each way, tensioned to 10% of their ultimate strength to provide a snug fit of bearing plate (on a mortar pad) to the rock, and then fully grouted with cement grout with a minimum specified unconfined compressive strength of 30 MPa at 7 days.

The bolt spacing was reduced and the longer bolts were installed in areas of intense foliation and large overbreak. Approximately 25% more bolts were

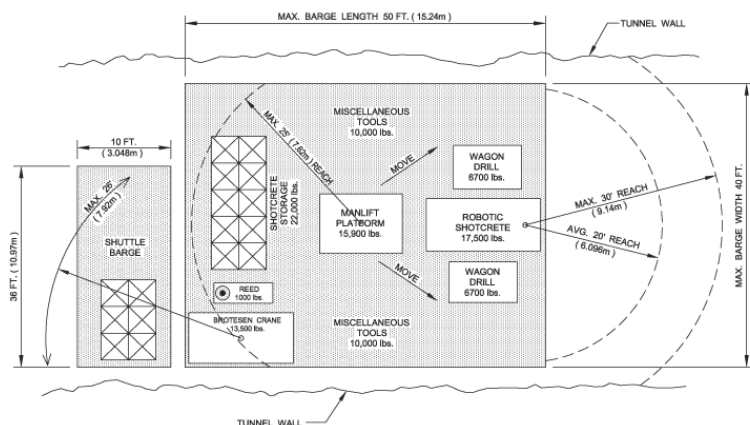
Figure 4. Barge arrangement.

The water level was drawn down to approximately 6 m below the arch at the altered zone, and a 15 m long, 12 m wide sectional barge was assembled at the tunnel portal as the primary work

platform. It was fitted out with a shotcrete plant complete with robotic shotcrete arm, wagon drills for rock bolt installation, and a personnel lift. The barge was taken to and remained at the work area, and a smaller shuttle barge delivered materials as required. Personnel moved between the portal and work area in small aluminium boats. Figure 4 is a sketch of the barges. Figure 5 shows the robotic arm for shotcreting, being tested at the portal. An initial inspection of the arch, scaling for safety, and installation of ventilation line were performed in advance of the support installation.

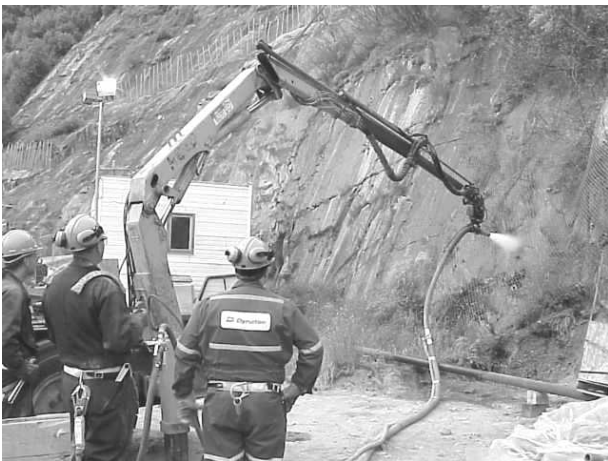
Figure 5. Robotic arm for shotcrete application.

Shotcrete thickness was controlled by setting depth gauges on the shotcrete anchors and probing during application. The latter method was problematic because of the dust and rebound and, in the arch in particular, the remoteness of the application with the robotic arm. Several check holes drilled after the shotcrete was completed, indicated average thicknesses of 140 and 170 mm in the arch and walls, respectively. Two check holes, low on the west wall, showed thicknesses of 90 to 95 mm; the shotcrete was accepted without thickening to the minimum specified 100 mm.
